PROJECT SHEET

RUSSELL RIVER AND JOSEPHINE CREEK BRIDGE BEARING REHABILITATION

Client: Queensland Rail

Location: Innisfail

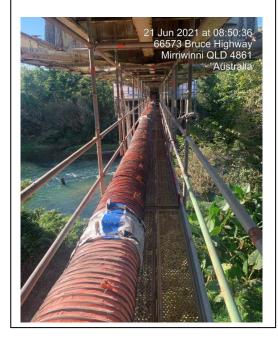
Walkway to Pier 2 showing scaffolding, ducting and encapsulation.
