BRIDGE 18 TOOWOOMBA SECOND RANGE CROSSING REPAIRS

PROJECT SUMMARY

Location: Bridge 18 Toowoomba
Second Range Crossing

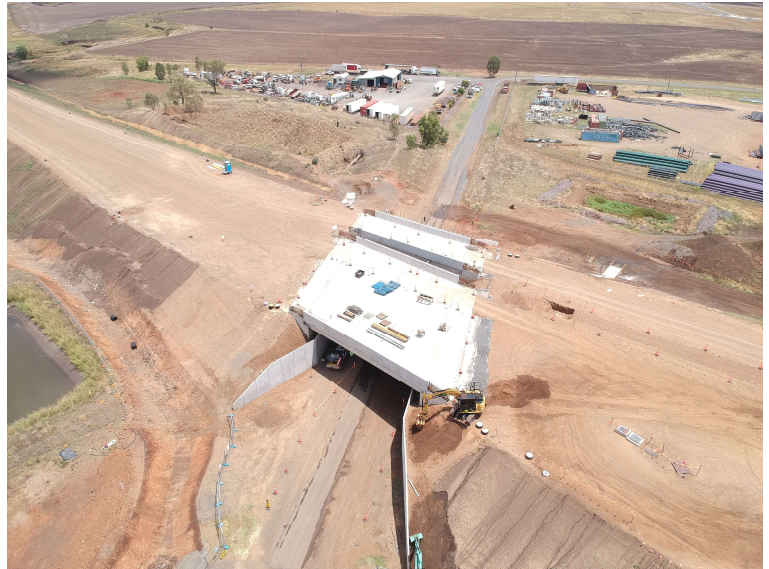
Two bridge deck units were damaged during the installation of Bridge 18. In addition, an excavator struck and damaged the underside of a third deck unit.

The damaged areas were sawcut and broken out, and the affected surfaces were prepared with mechanical key insertions. The deck units were reformed with structural repair mortar. The form boards were left to cure over the 7-day minimum period. Once cured, the deck units were finished off with a render coat.

Three structural deck units were repaired using a form-and-pour method, with Renderoc LA55 and rendered with Renderoc FC.
