PROJECT SHEET

WORLEY LANE RESERVOIR REMEDIATION

WORLEY LANE RESERVOIR (1.2ML)

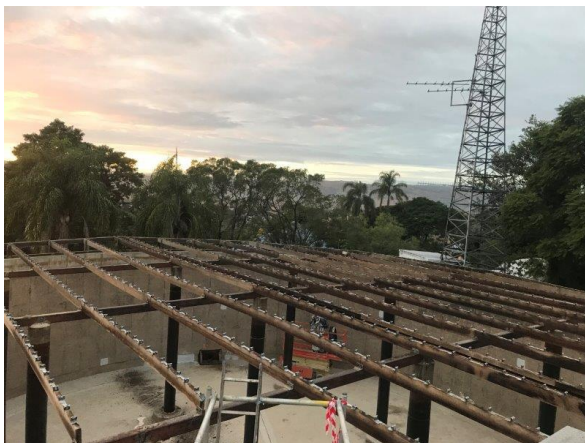
Steel and timber roof structure

The steel and timber roof structure were removed and replaced with a new aluminium structure.

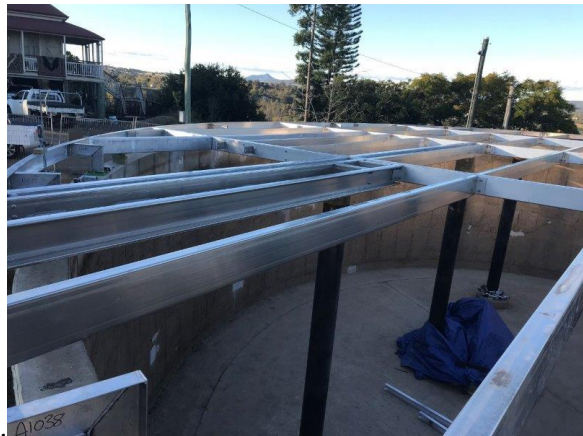
New Aluminium Roof Structure

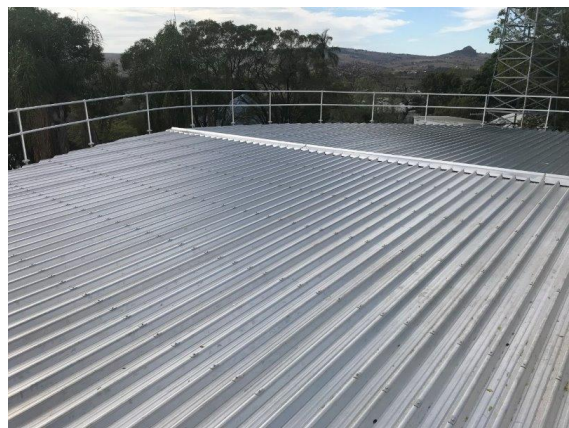
New Aluminium Roof and perimeter handrail

The steel roof was replaced with an aluminium roof and a new perimeter handrail installed.

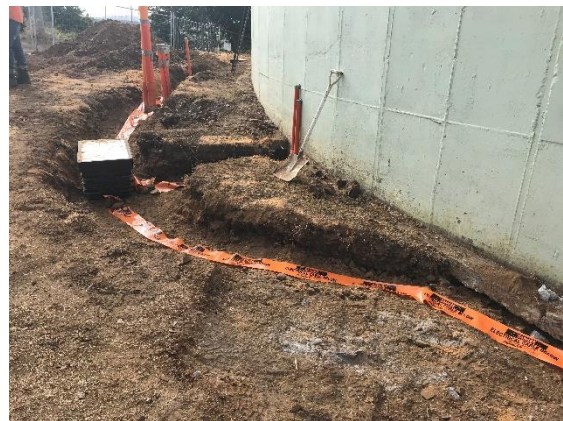
Trenching for electrical ducts and service pits

New ducts and electrical pits were installed for the new electrical and comms cables.

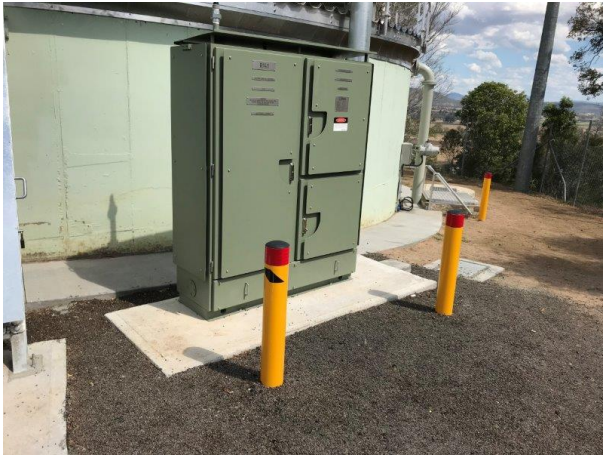
New Switchboard

A new switchboard was installed along with protective vehicle ram bollards. The software programming and electrical works were done by designated expert subcontractors.

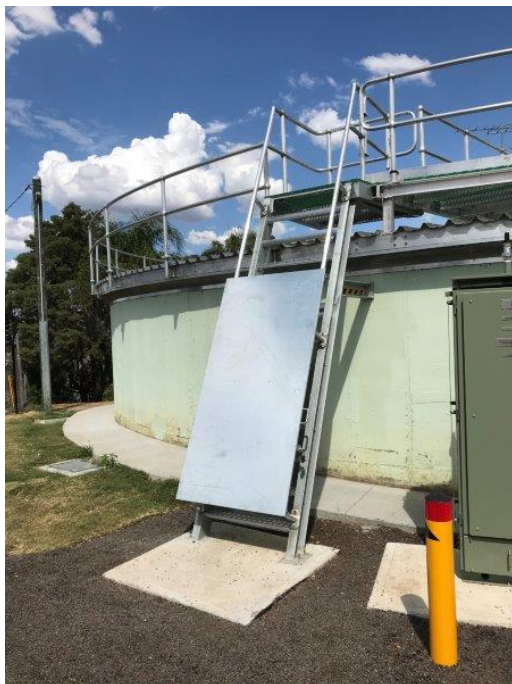
New stepladder with anti-climb security

A new stepladder with landing platform was installed. This included an anti-climb security cover and a perimeter handrail around the landing platform.

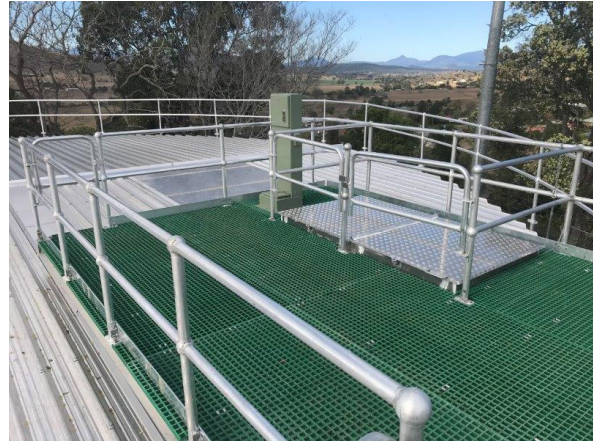
Roof platform and access hatch

A roof platform and entry hatch were design and installed for safe access. FRP was used for the grating and the hatch and handrail form aluminium.

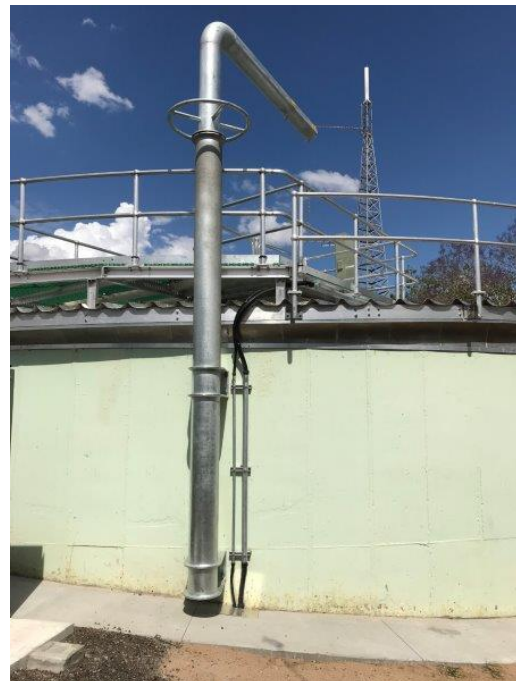
New load rated davit arm

A new davit arm was installed and tested. It was rated to 125g SWL with fall arrest point to 15kN Max.

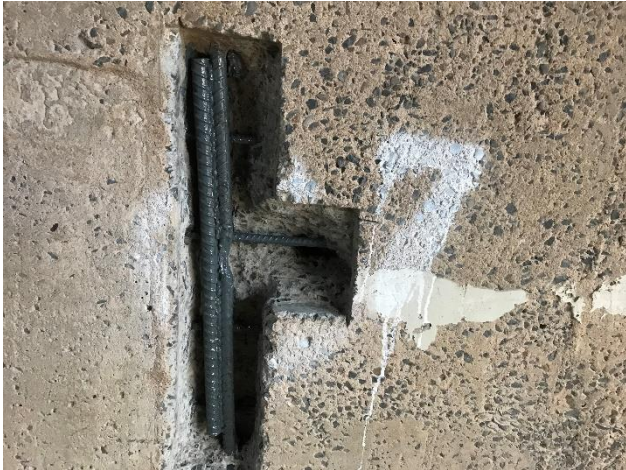
The concrete walls had many defects where the reinforcing was corroding. Steel reinforcement was replaced in five separate repairs where the sectional area loss caused by the damage was more than 30%.

Steel reinforcement replacement

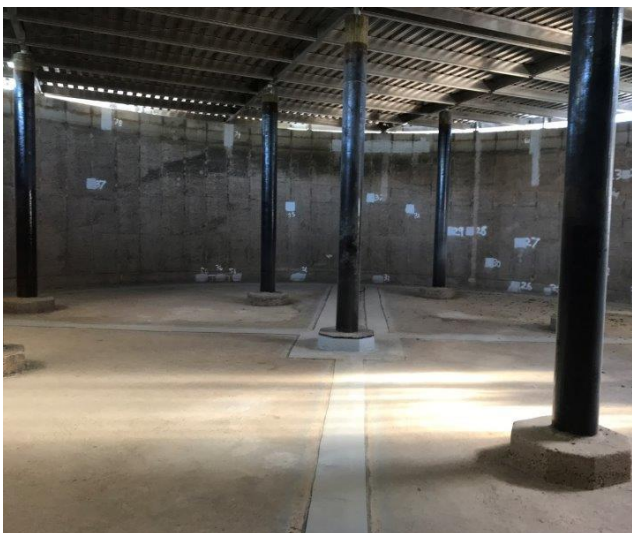
Expansion joint preparation

The photo below shows the slab expansion joints that were cleaned, sealed, and sprayed with a 350mm wide polyurea bandage and concrete repairs on the reservoir internal walls

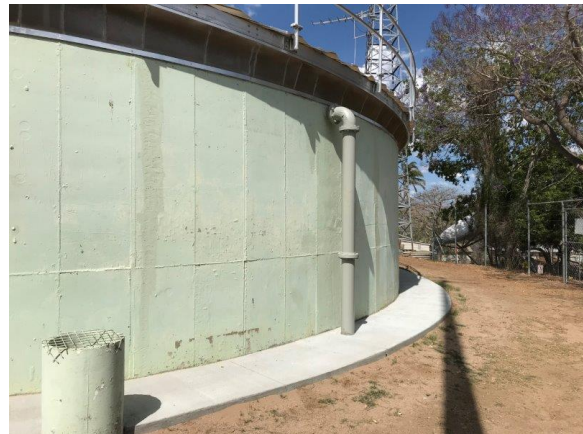
Newly coated overflow pipe and perimeter apron

The overflow pipe required a new AS4020 coating. The previous coating was removed by sandblasting the pipe to achieve a defined surface profile and finish. The overflow pipe was coated with three epoxy coats.

A 1m-wide concrete apron was installed around the perimeter of the reservoir.

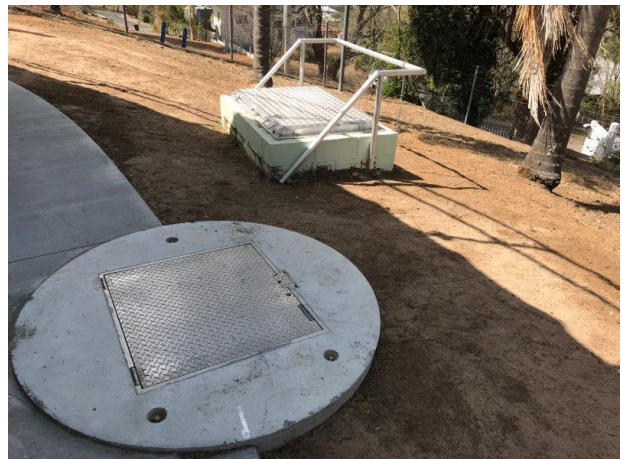
Manhole and flow meter covers

A new concrete manhole frame and cover was installed over the outlet pit and a new aluminium frame and cover installed for the flow meter pit.

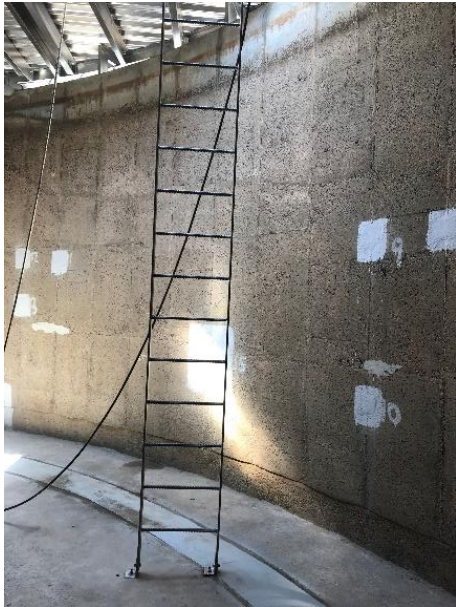
Stainless Steel access ladder

A 316 stainless steel ladder was designed, fabricated, and installed at the access hatch.

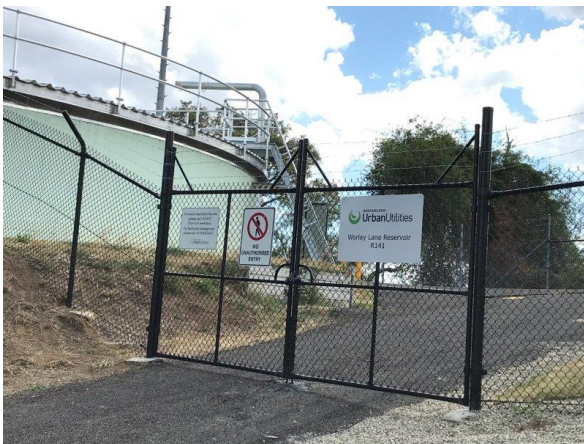
New access gate

New fence lines were installed, enlarging the property perimeter. The resulting increased reservoir parking area was resurfaced along with the existing access road, which was lengthened. A new driveway was constructed as an alternative access at No. 2 Worley Lane.
