BICENTENNIAL BIKEWAY BEARING REPLACEMENT

PROJECT SUMMARY

Location: Bicentennial Bikeway,
Brisbane

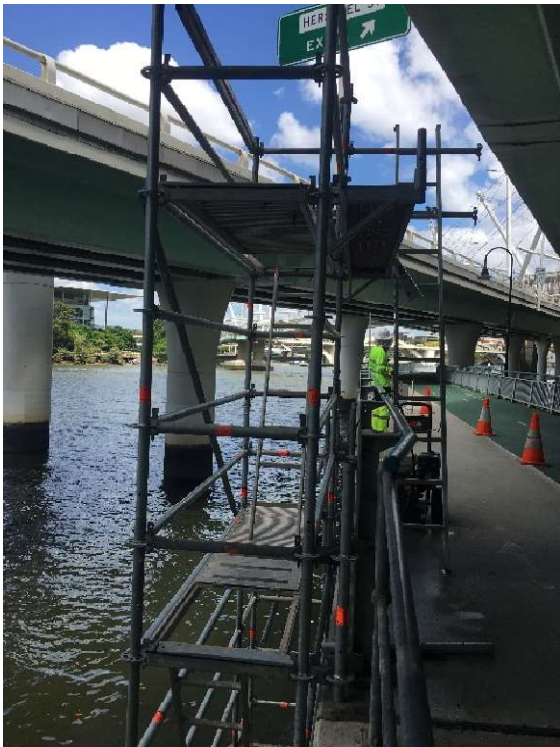
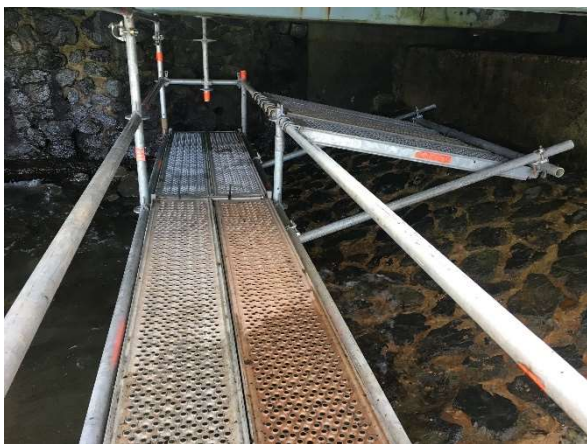
A temporary work access platform was constructed adjacent to the abutment. The platform could easily be removed for spring high tides.

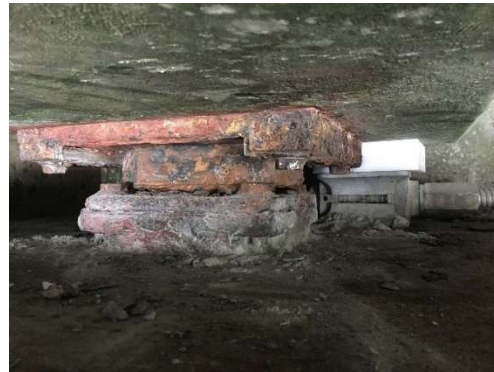
Wedge jacks were installed behind the existing bearings as a safety measure in case the hydraulics failed.

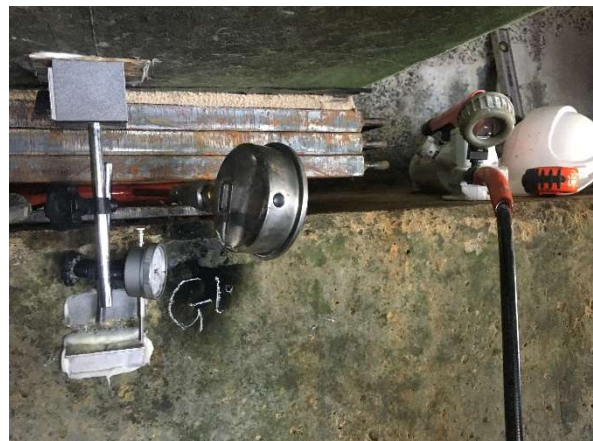
Dial gauges were installed to monitor the jacking process.

The dial gauges had a magnetic base which was epoxied to the concrete and could be placed in many locations.

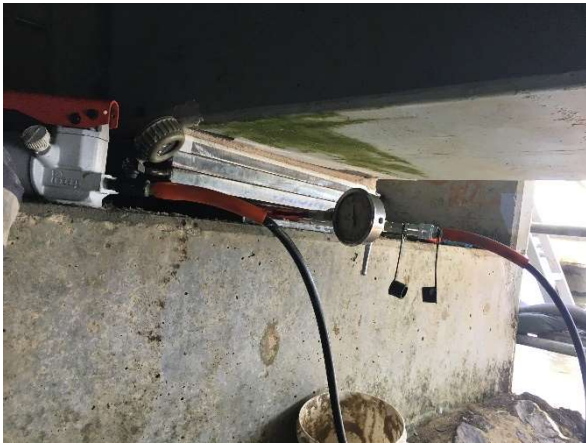
Both jacks were simultaneously employed so that nominal lift was achieved on both. This was enough to relieve the loading on the bearings.

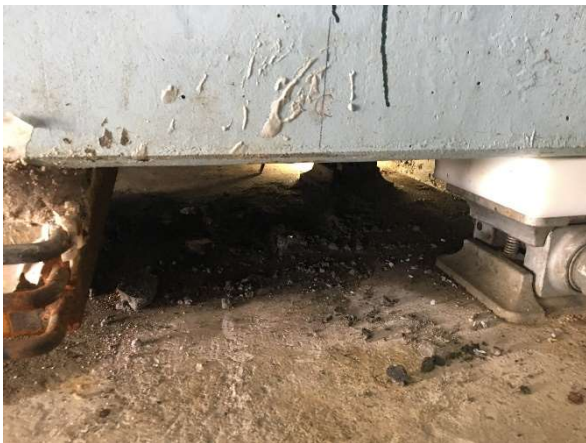
The jack hold valve was activated and locking collar engaged to ensure that even if hydraulic fluid was lost, the jack would hold the load and position.

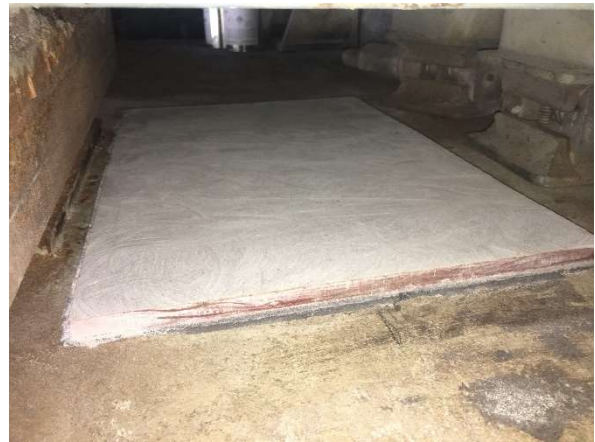
Once the jacks were safely carrying load, the pot bearings were removed. The headstock and girder were mechanically cleaned to provide an even surface for the elastomeric bearings.

An epoxy mortar pad was installed

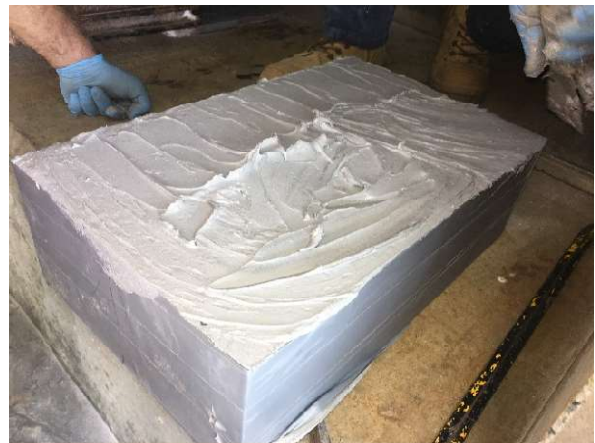
Below: The epoxy mortar mixed, and elastomeric bearings installed.

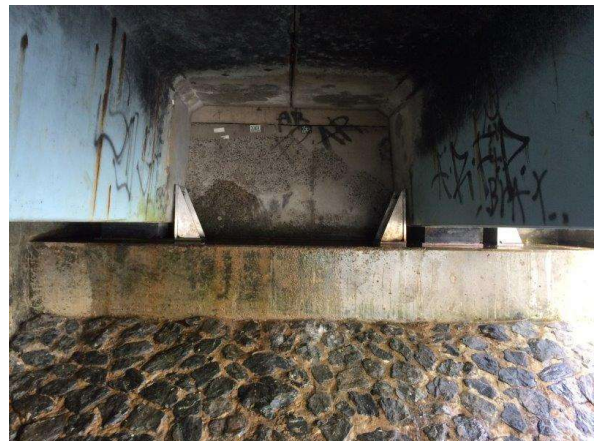
The flat jacks were removed, and stainless steel restraints were re-installed
